# Manhole Inspection Summary

Manhole # S21M\_\_047MH

Insp Date: **3/21/08 8:27 AM**

**Location** Address: **1900 ramsay st**

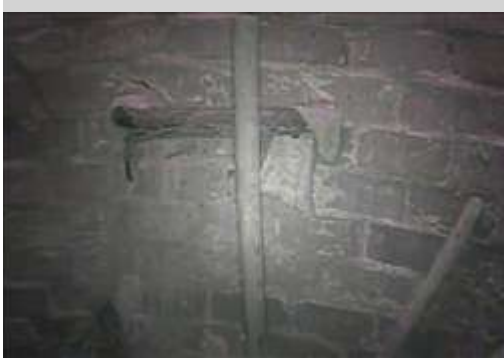
Defect 4

**Surcharge** ☒ **Evidence Of Surcharge** Depth: **4** (ft.) ☐ Active Surcharge Present

surcharge evidence

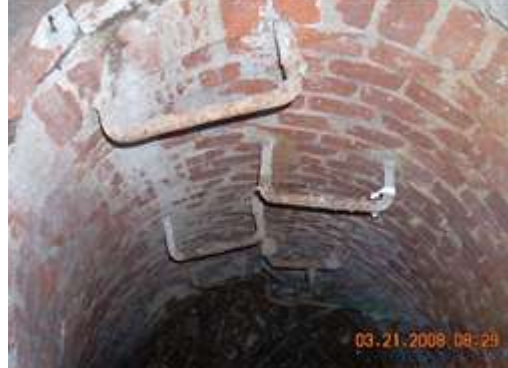
Defect 3

**Steps** Count: **6** Missing: **0** ☒ **Corroded**

corroded step

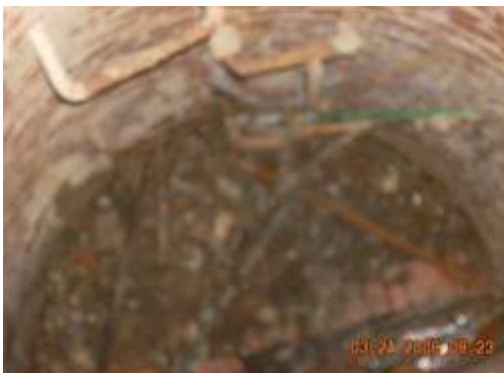
Defect 2

Condition: ☐ Sound ☐ Cracked ☐ Root Intrusion ☐ Deteriorated ☐ Leaks ☒ **Debris**

debris on bench

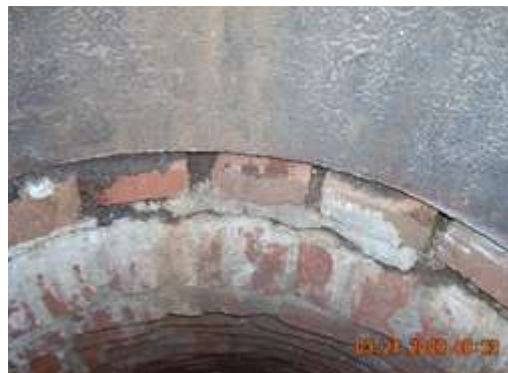
Defect 1

Condition: ☐ Sound ☐ Cracked ☐ Root Intrusion ☒ **Loose Brick** ☐ Deteriorated

loose brick on right

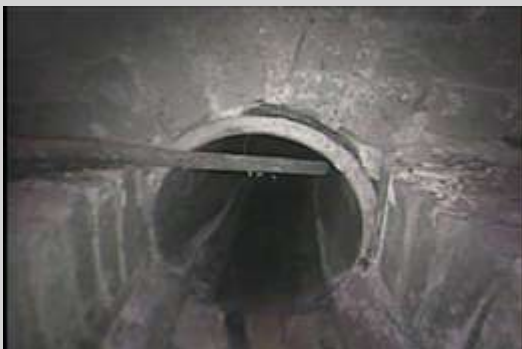
9 O'Clock Inflow

Pipe Height: **8.4** (in.) Rod and Bar (Angled)  
Pipe Material: **Clay** ☐ Pipe Lined  
Invert Depth: **9.39** (ft.) Flow Characteristics: **Slow**  
Deposits: ☒ None ☐ Mud ☐ Sludge ☐ Debris ☐ Grease  
Silt Depth: **0** (in.) Deposits Extent:  
Infiltration: **None** Pipe Seal Cond: **Cracked**
